# ALTERNATOR & REGULATOR - MITSUBISHI

1990 Nissan 240SX

1990 ELECTRICAL  
Nissan Alternators & Regulators - Mitsubishi

Pulsar, Sentra, Stanza, 240SX

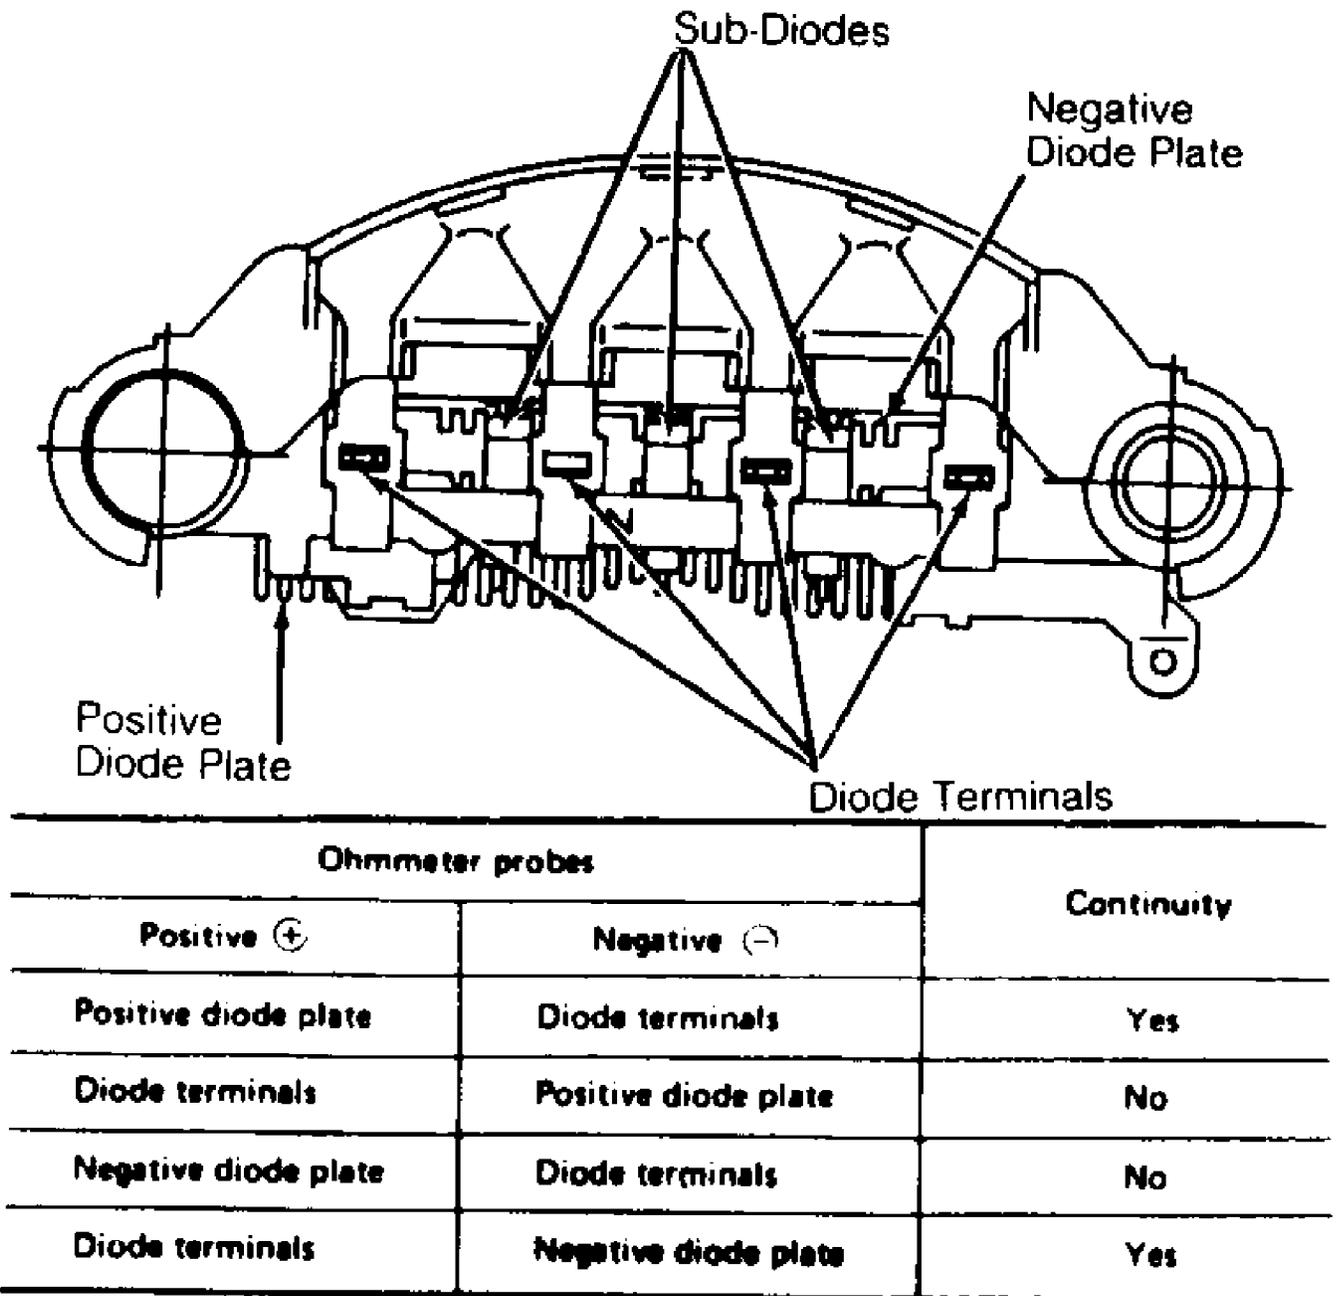
Fig. 1: Testing Diode Assembly  
 Courtesy of Nissan Motor Co., U.S.A.

Using an ohmmeter, check continuity of all diodes in both directions. Continuity should exist in only one direction. If continuity exists in both directions, diode is shorted. See Fig. 1. If continuity is NOT present in either direction, diode is open. If any diode is defective, replace entire diode assembly.

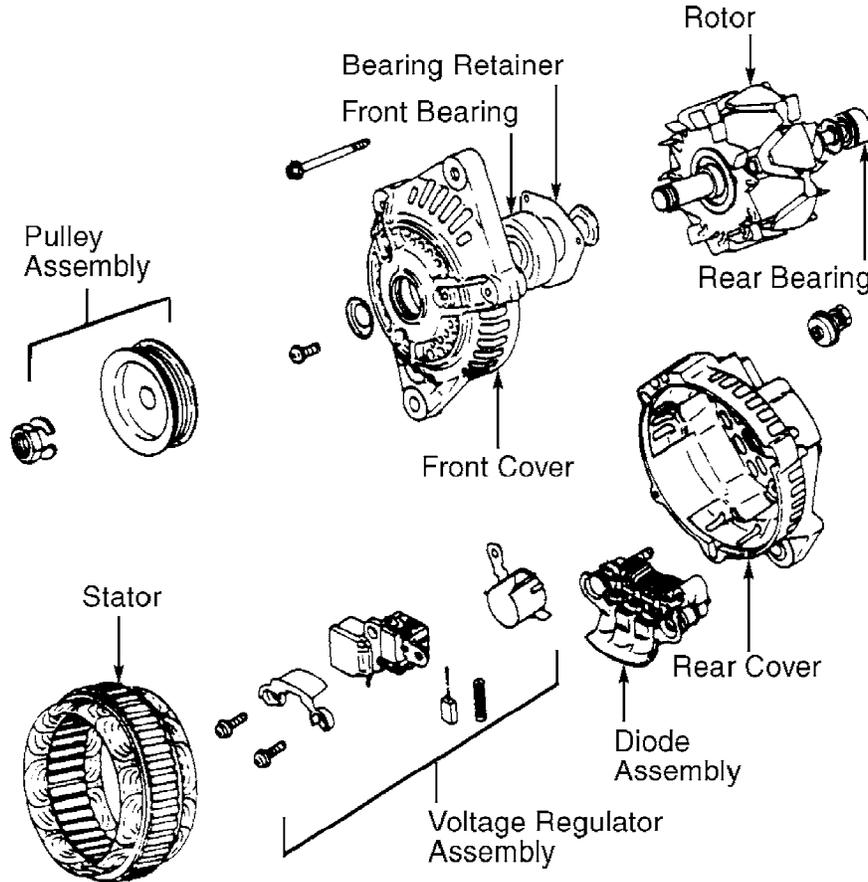
90E09390  
 Fig. 2: Exploded View of Mitsubishi Alternator  
 Courtesy of Nissan Motor Co., U.S.A.

NOTE: A ring is used to lock outer bearing race in alternator's rear cover. It may be necessary to heat bearing housing to remove cover. Use 200 watt soldering iron to heat housing. DO NOT use heat gun, as it may damage diode.

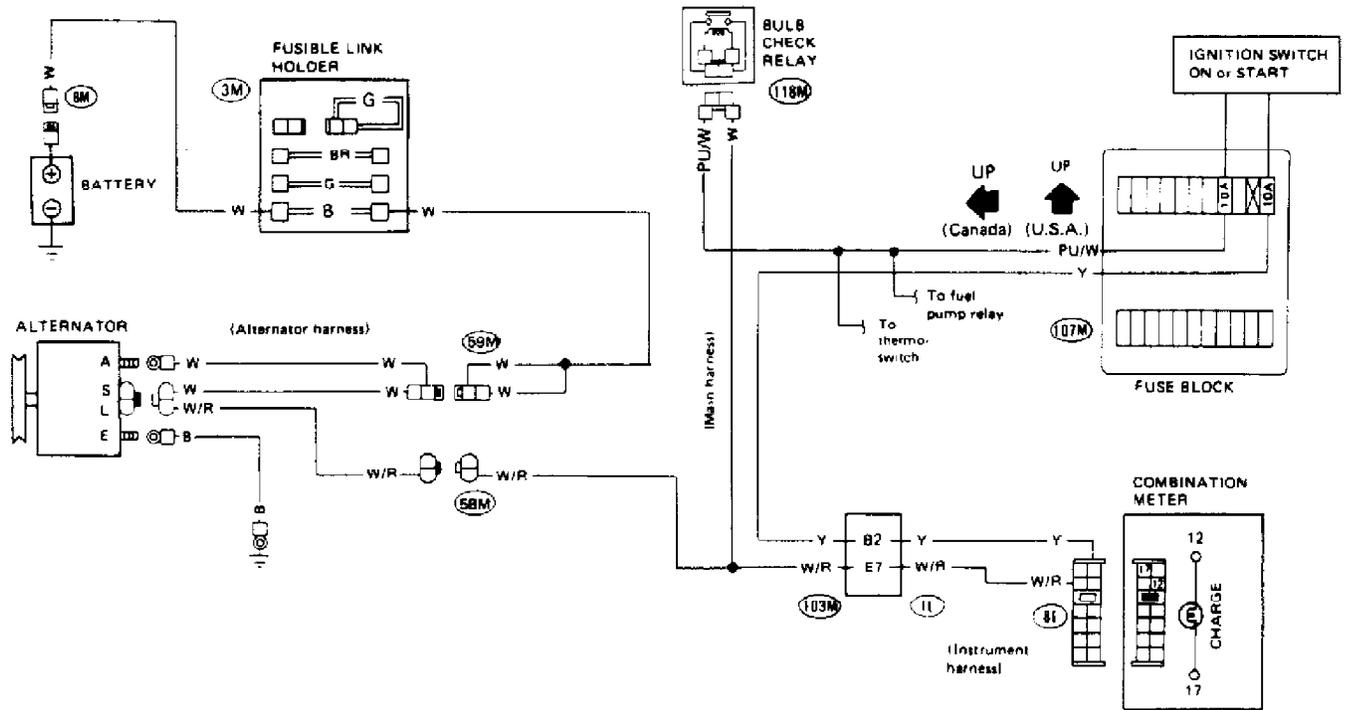
Fig. 3: Pulsar NX Charging System Wiring Schematic (Others Similar)  
 Courtesy of Nissan Motor Co., U.S.A.
